Architectural Testing, Inc.
37483 Interchange Dr., Farmington Hills, MI 48335
Phone: (248) 957-9911

March 12, 2021

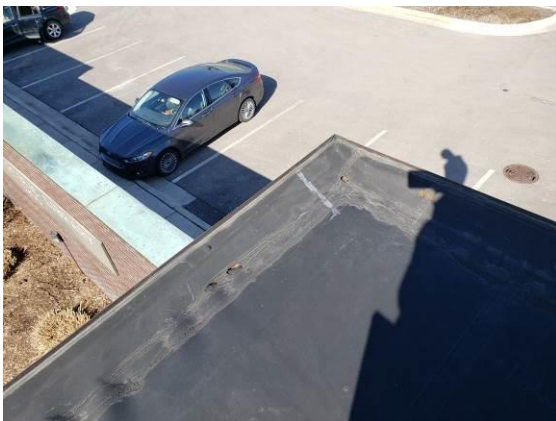
3. Holes found in the NW corner of the east area. The wood blocking at the edge visible through the holes.

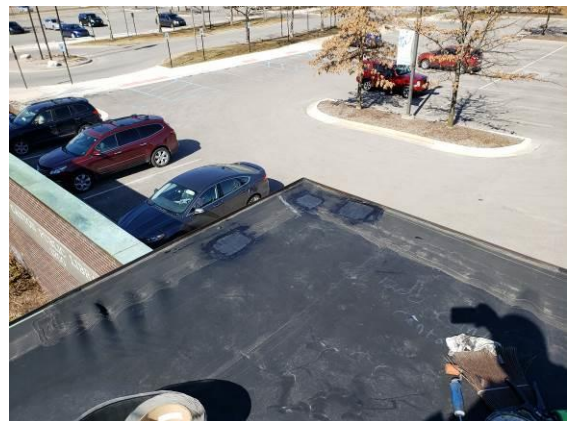
4. Intertek installed repair patches over these holes.

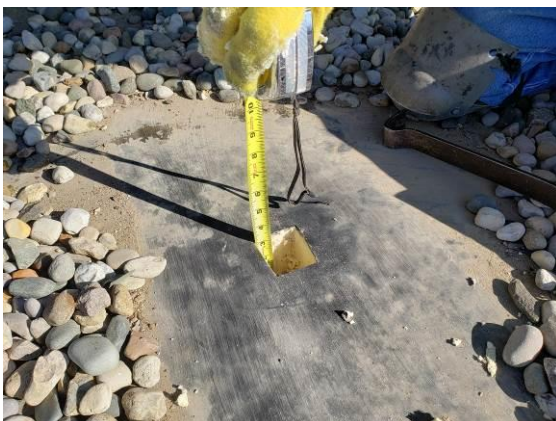
5. View of a typical core in the main roof areas. A single layer of 3" thick rigid isocyanurate foam found over a steel roof deck.

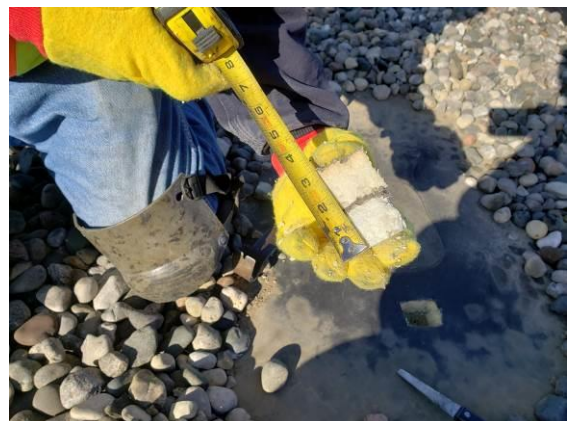
6. View of the roof core from the smaller south building addition where two layers of 1.5" foam exist.

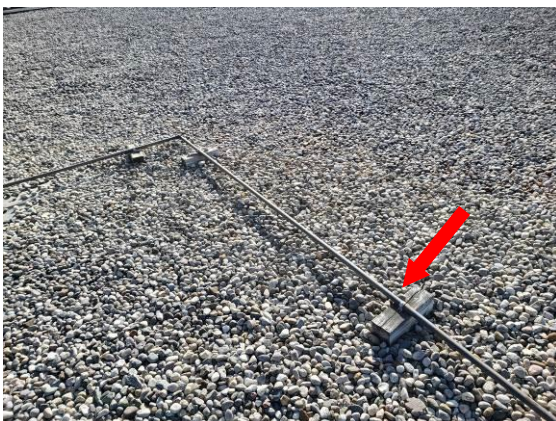
17. Another view of the existing conduit and conduit supports on the ballasted roof. With the replacement roof, newer style supports could be added that may be better systems than simple wood blocking supports.

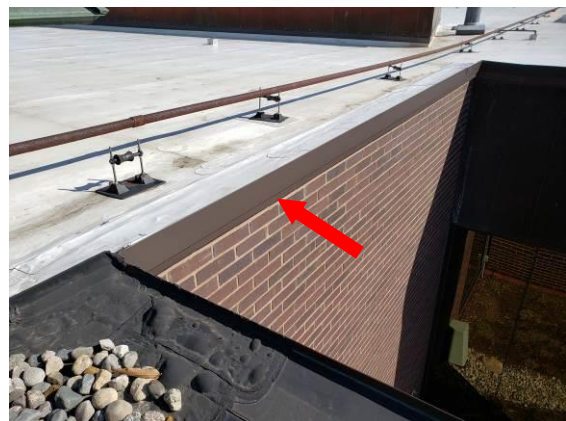
18. View of how roller supports were installed during the 2008 work and a view of the metal edge assembly on the 2008 work. It may be desired to match the look of the metal.

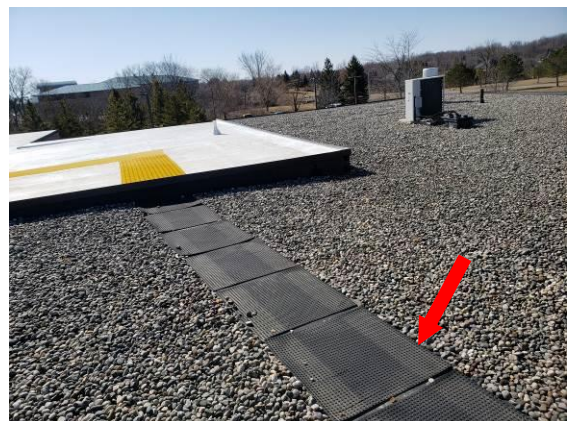
24. Typical existing walk pads. With replacement roof new safety yellow walk pads could be installed, similar to those installed in 2008.

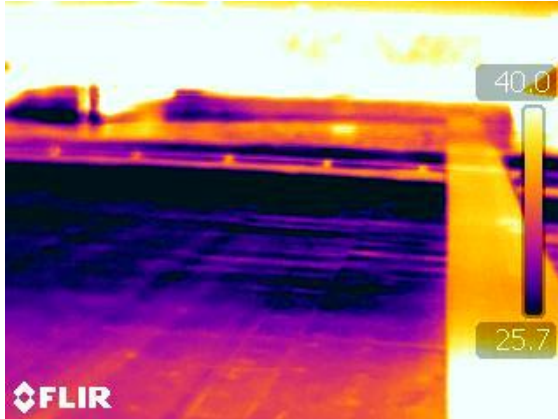
1. Image 1. Walkway visible (as would be normal) in one of the 2008 smooth surface areas. No localized heat images that would be suspect of representing wet insulation.

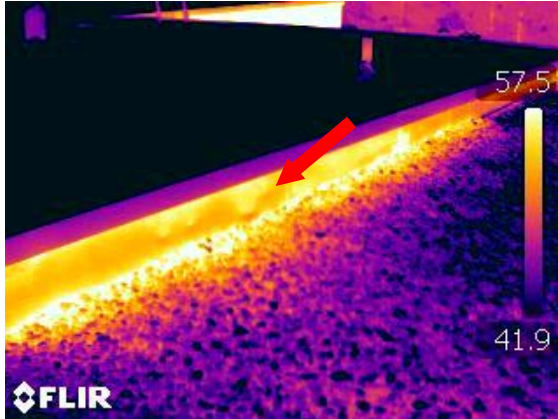
7. Image 7. Heat loss at the raised area divider curb. This is not believed to be due to wet insulation, but perhaps air leakage from the insulation to the wood curb.

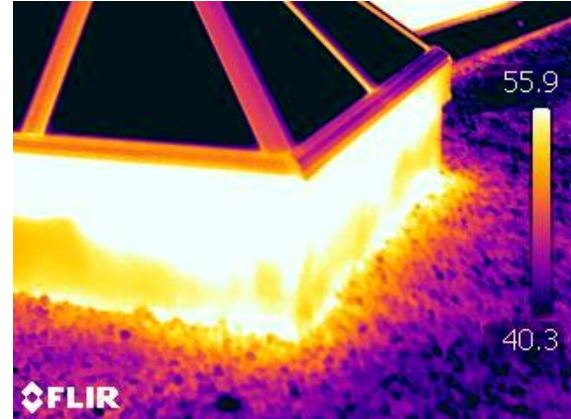
8. Image 8. Heat loss at the curb of the skylight. No obvious heat images in the ballasted system.

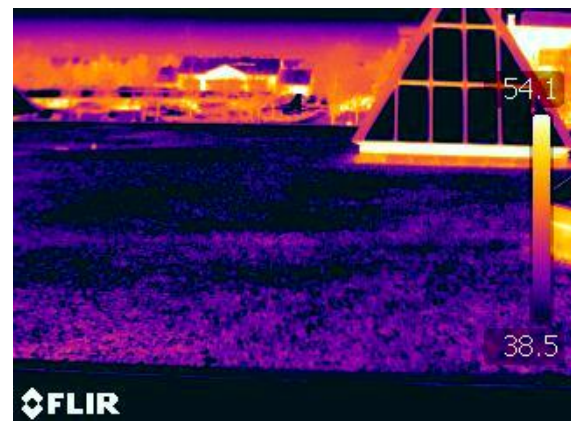
12. Image 12. Another view of a large section of ballasted EPDM with no observed heat loss areas.

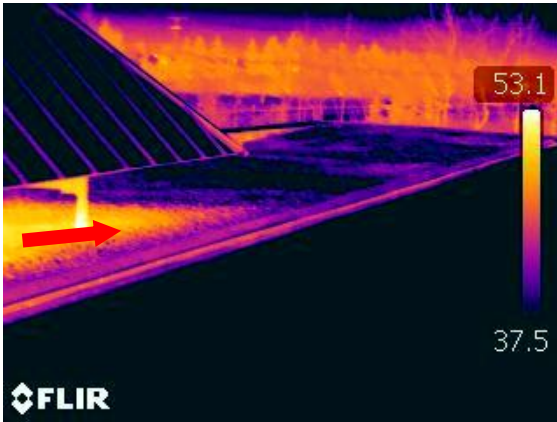
13. Image 13. The rock ballast is "warmer" under the screen wall, which is normal as the heat is held in place by the overhang condition and the heat from the unit.

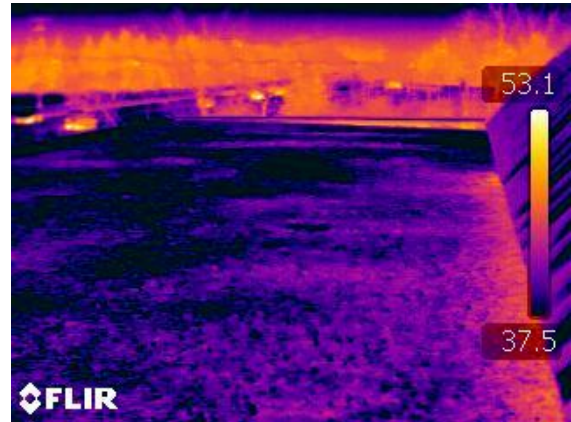
14. Image 14. No observed heat images that would indicate wet insulation in this ballasted section.

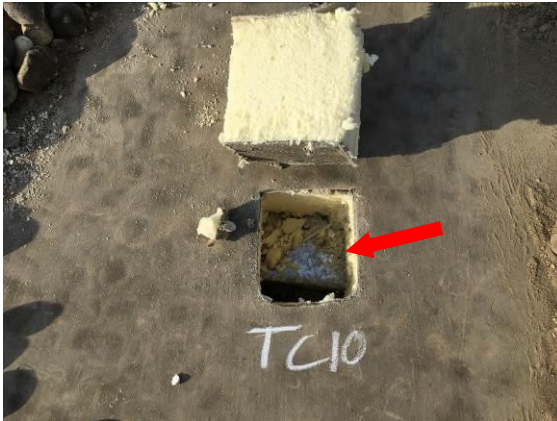
15. Photo of Test Cut #10. Insulation found dry to touch.

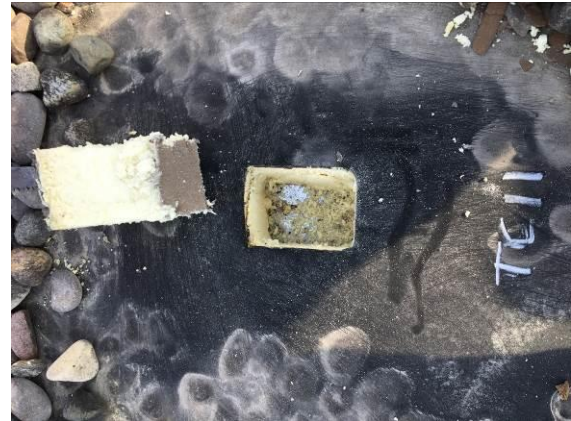
16. Photo of Test Cut #11. Insulation found dry to touch.

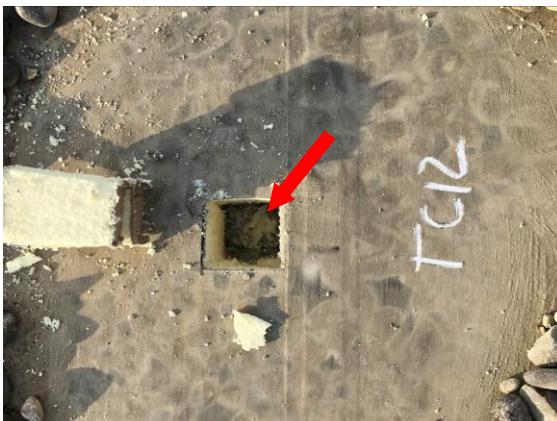
17. Photo of Test Cut #12. Insulation found dry to touch.

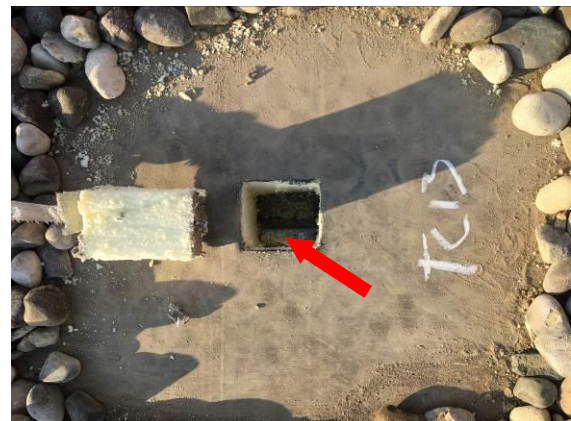
18. Photo of Test Cut #13. Insulation found dry to touch.

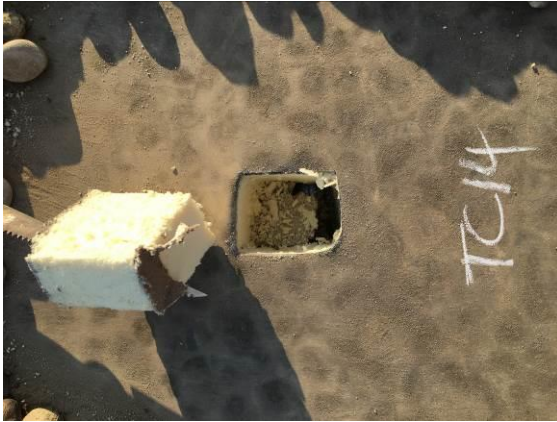
19. Photo of Test Cut #14. Insulation found dry to touch.

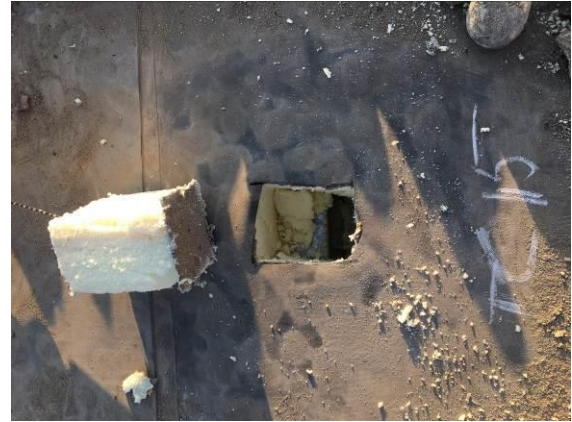
20. Photo of Test Cut #15. Insulation found dry to touch.

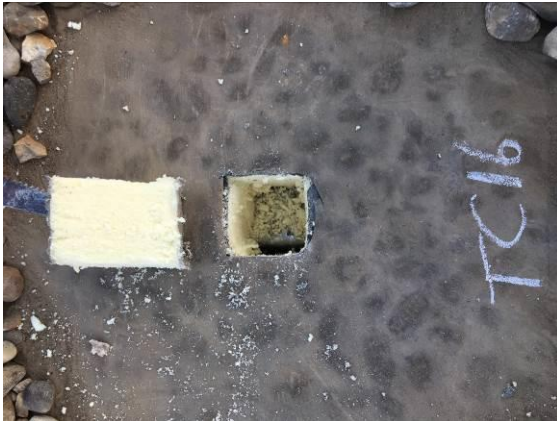
21. Photo of Test Cut #16. Insulation found dry to touch.

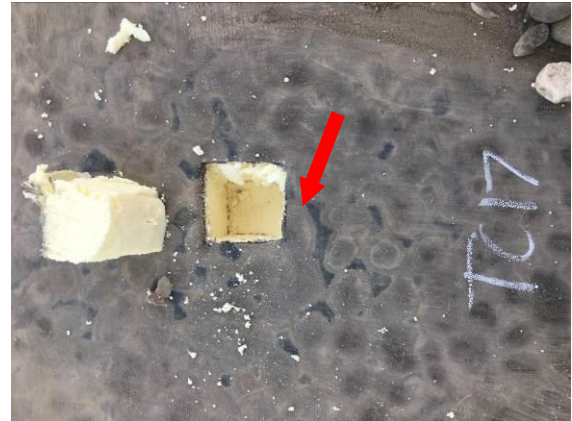
22. Photo of Test Cut #17. Insulation found dry to touch.

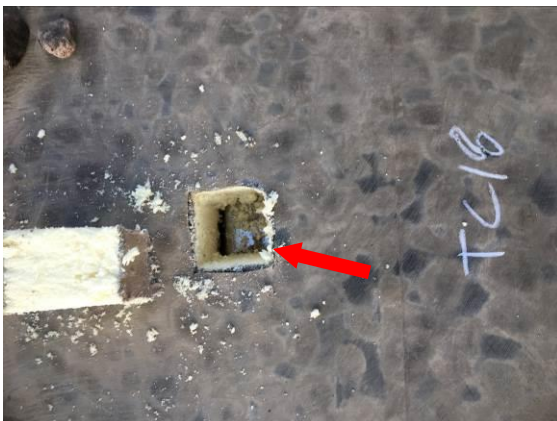
23. Photo of Test Cut #18. Insulation found dry to touch.

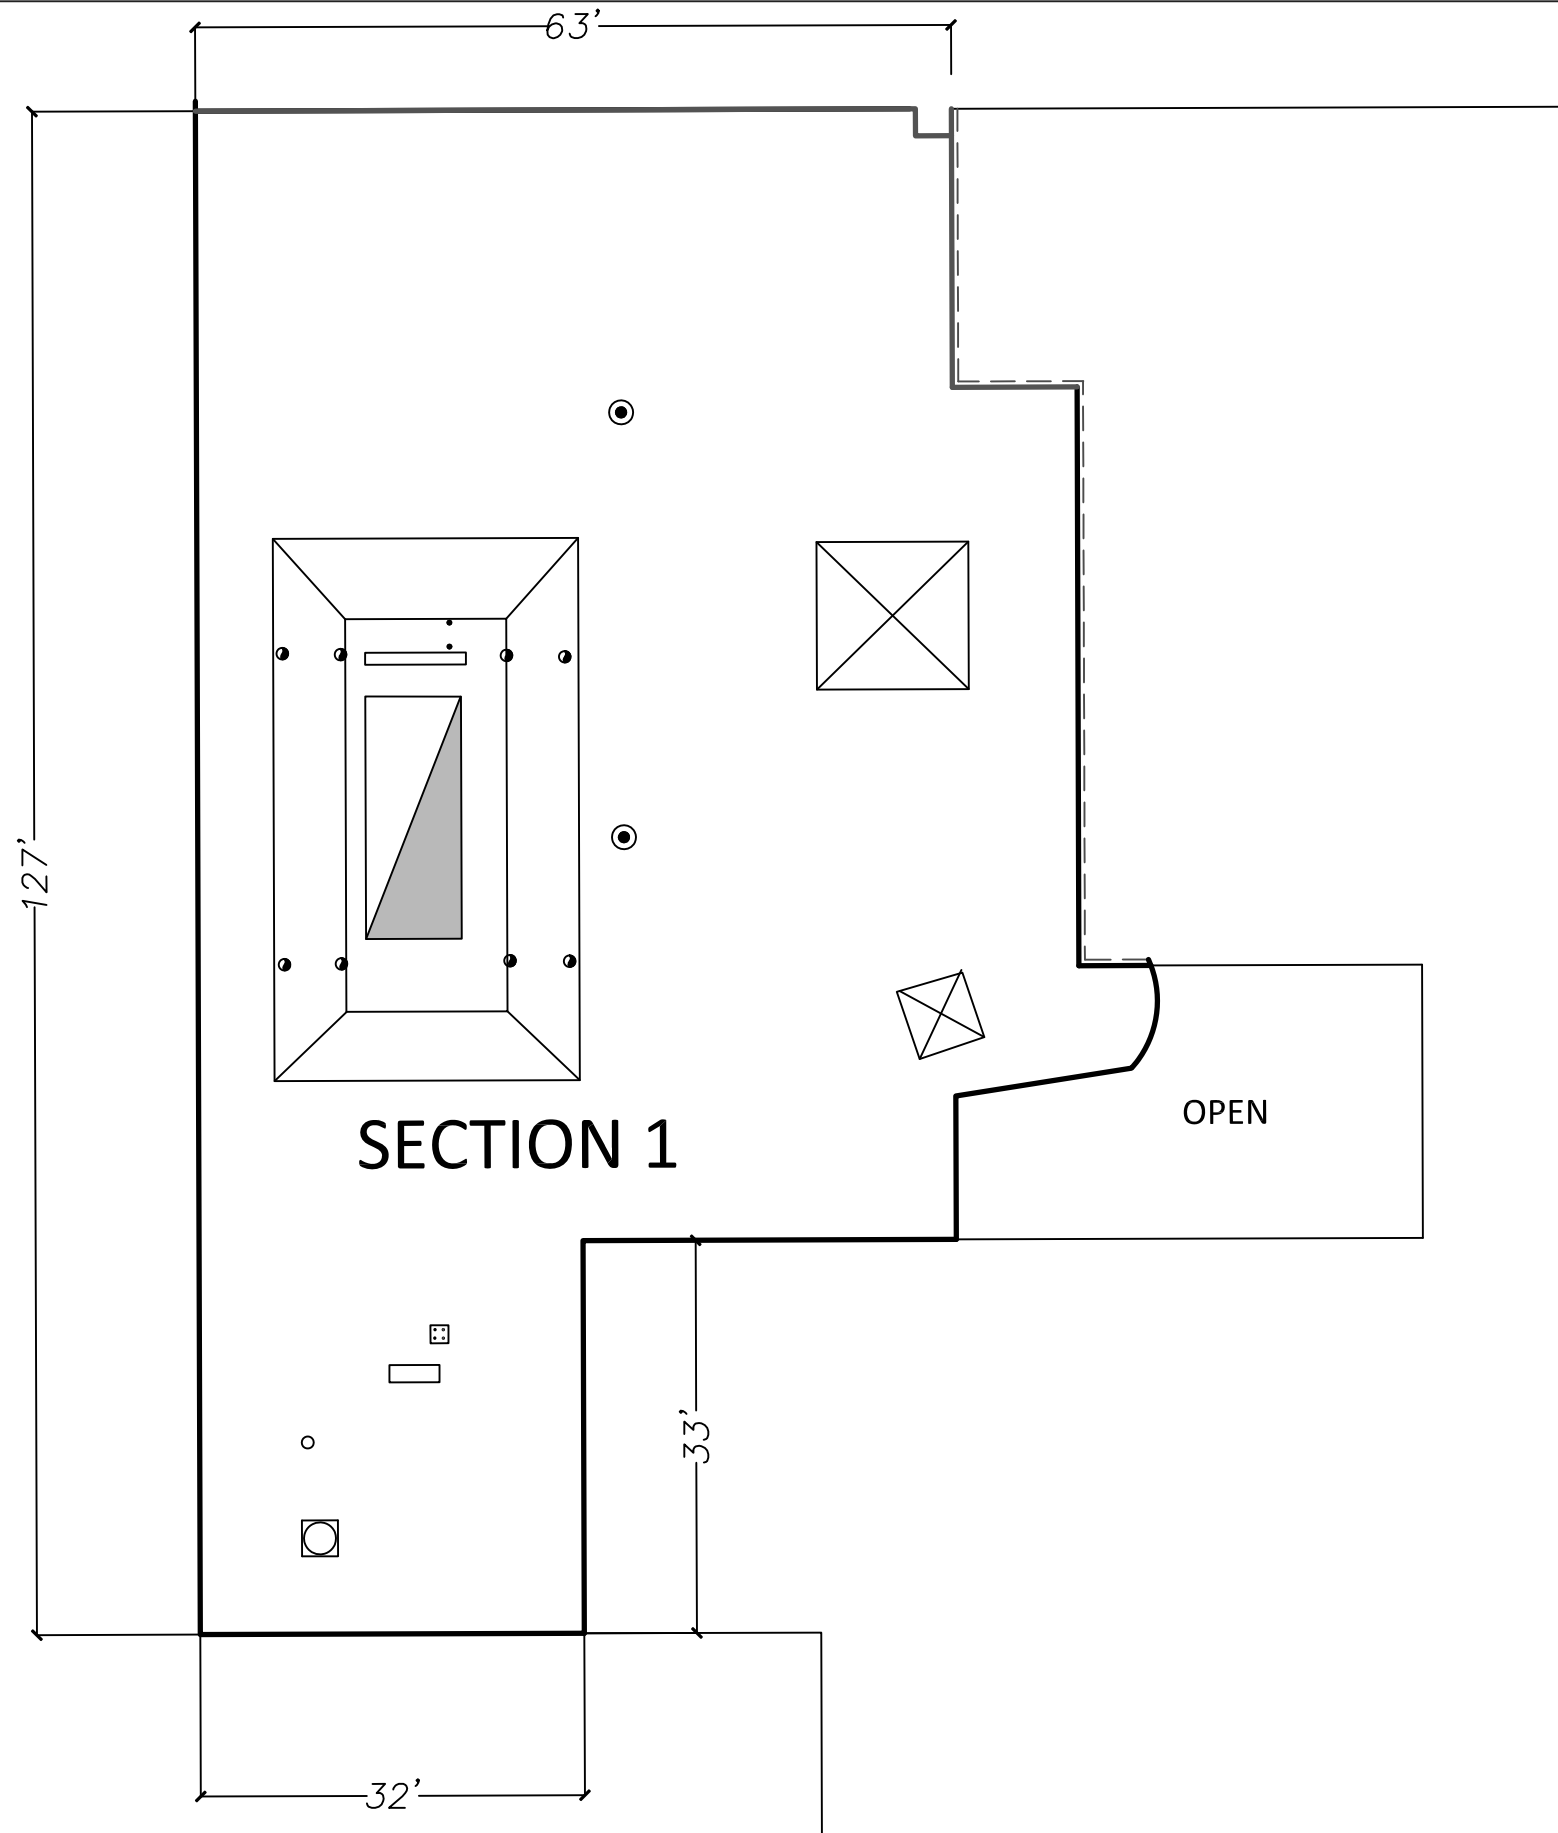
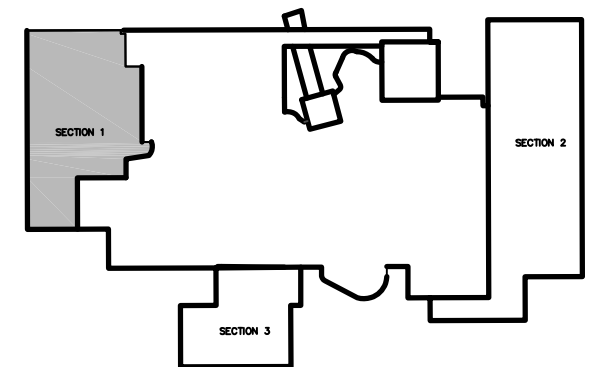
○	PLUMBING VENT (SOIL STACK)
∅	HOODED VENT
▣	AIR CONDITIONER
■	PITCH PANS
●	PIPE PENETRATION
---	DIVIDER WALL
⊕	CORE LOCATION
—	GAS LINE
□	EXHAUST FAN
⊙	ROOF DRAIN
●	SUPPORT PIPE

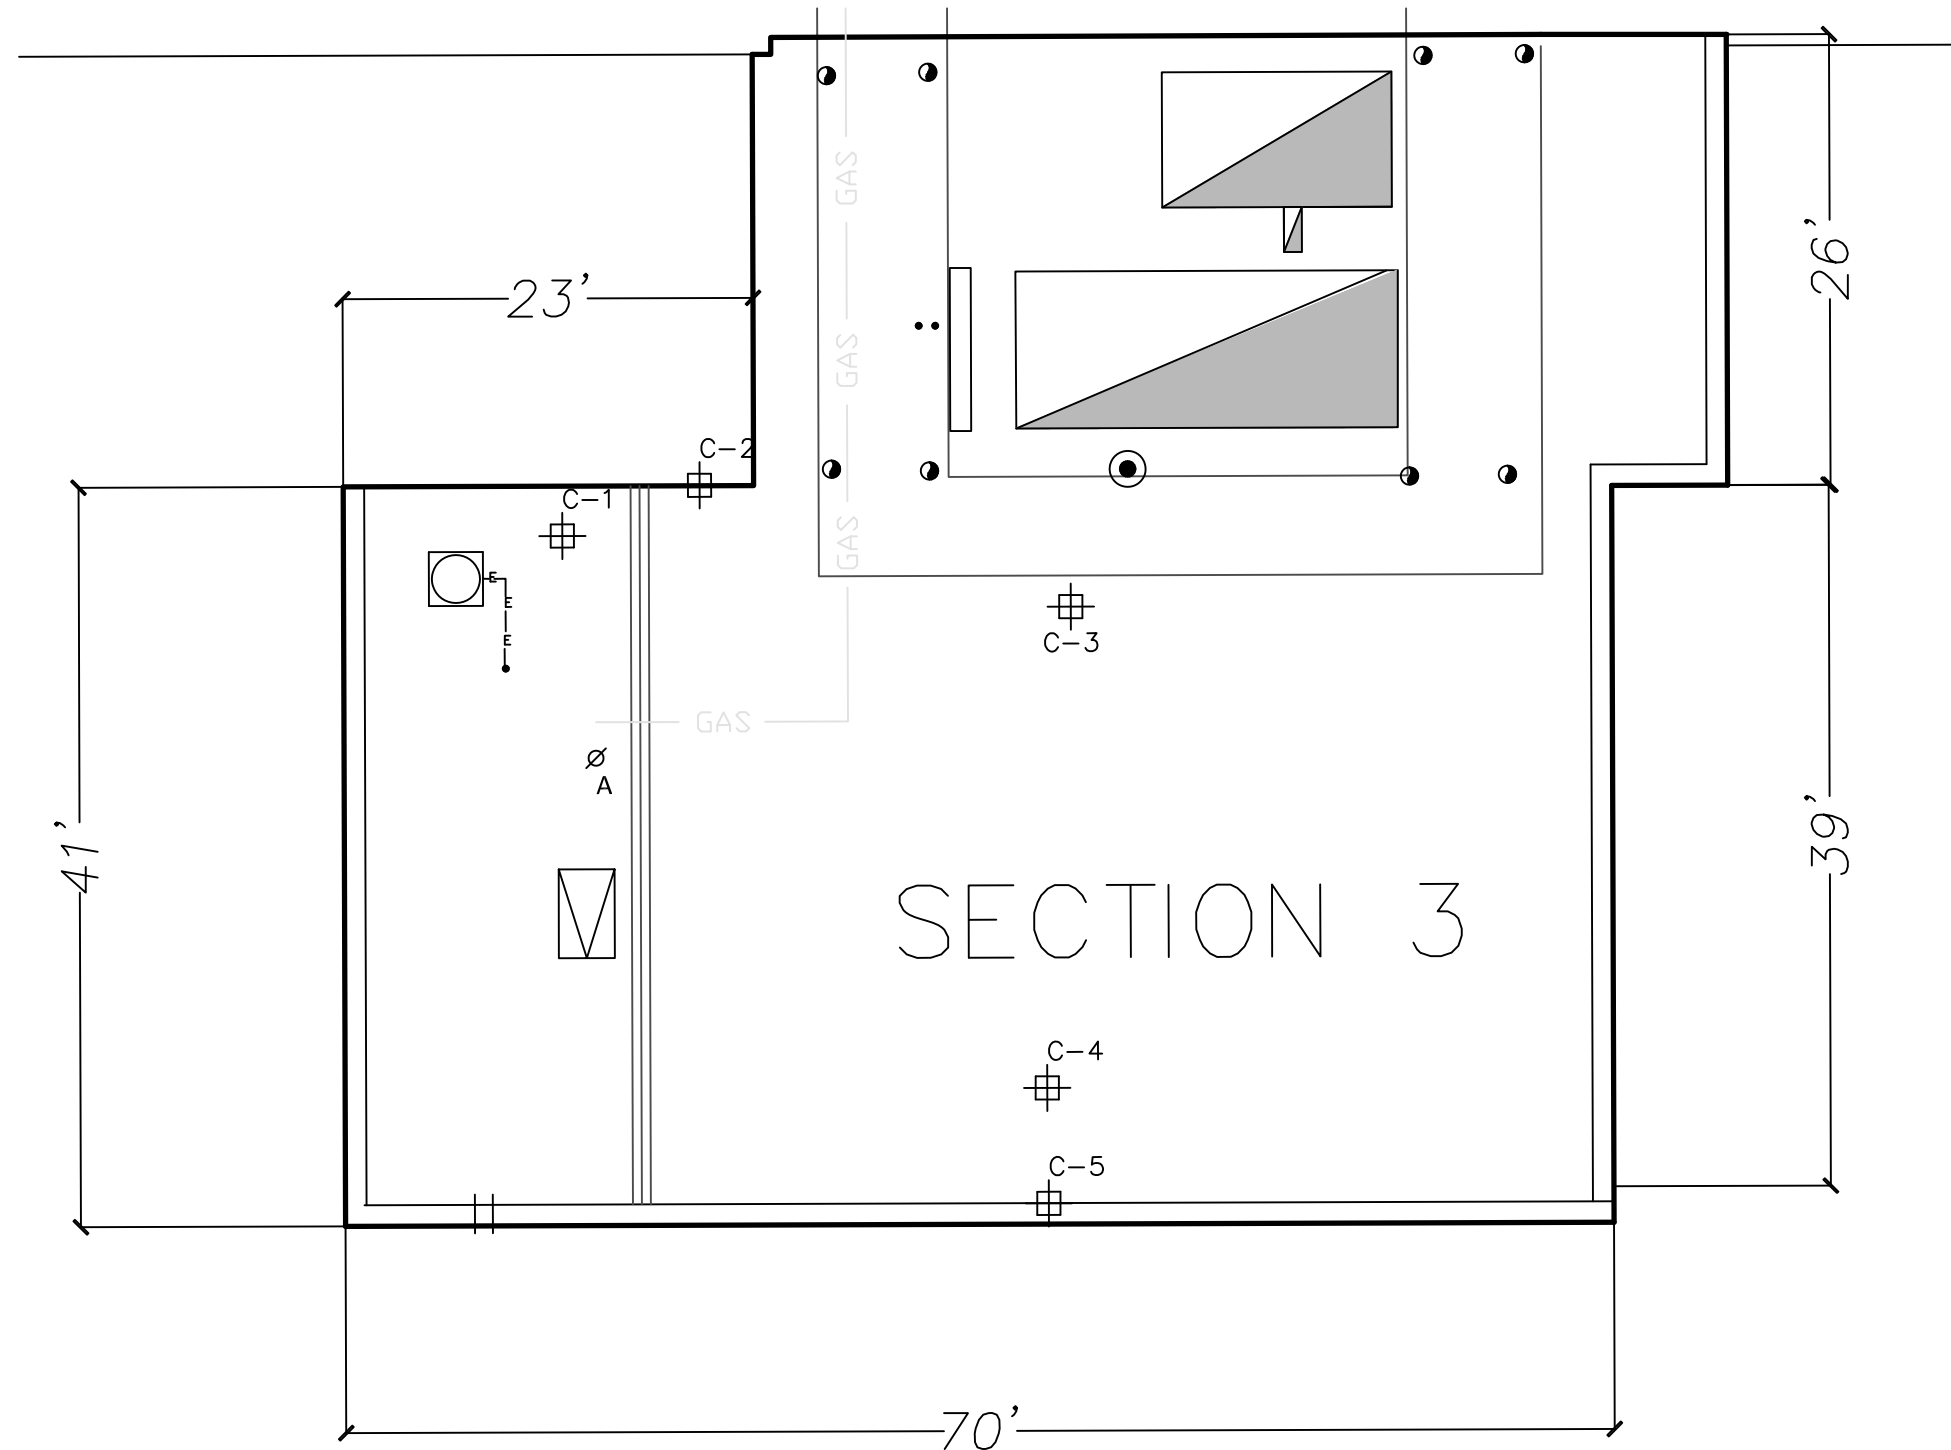
ROOF AREAS	
SECTION	SQ. FT.
1	7,660
2	10,871
3	4,248
TOTAL	22,779
